# Intel® Core™ 2 Extreme Processor X6800<sup>Δ</sup> and Intel® Core™ 2 Duo Desktop Processor E6000<sup>Δ</sup> and E4000<sup>Δ</sup> Sequence

## Specification Update

*— on 65 nm Process in the 775-land LGA Package supporting  
Intel® 64<sup>Φ</sup> Architecture and Intel® Virtualization Technology±*

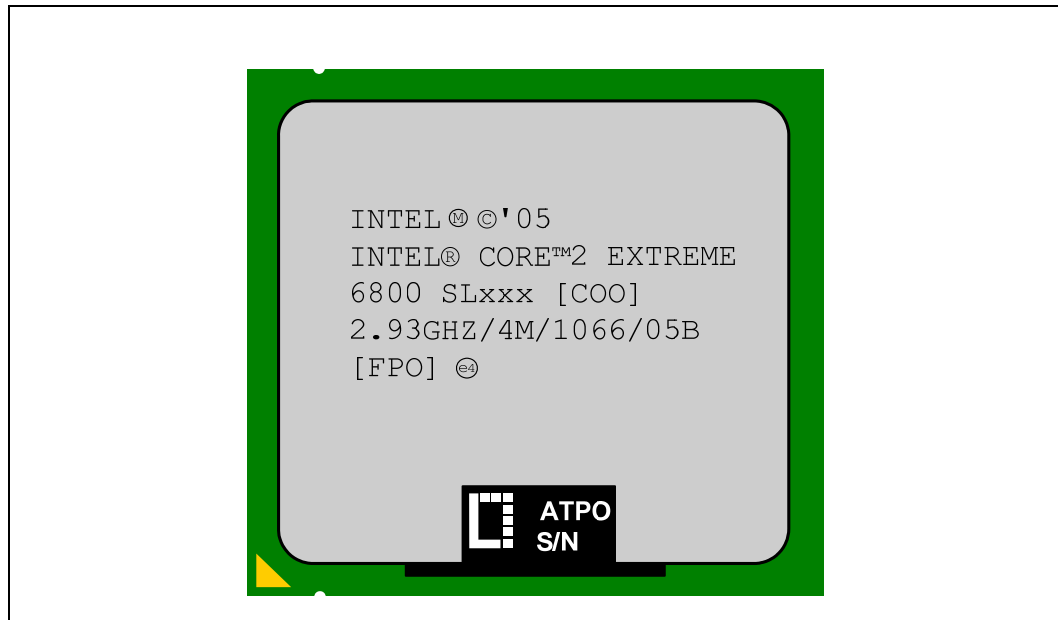
Figure 5. Intel® Core™2 Extreme Processor Package
